Engineering Assessment of Big House at Summit Station, Greenland

Final Report

Lynette A. Barna, Keran J. Claffey, James S. Buska,
and Jennifer L. Mercer

April 2011

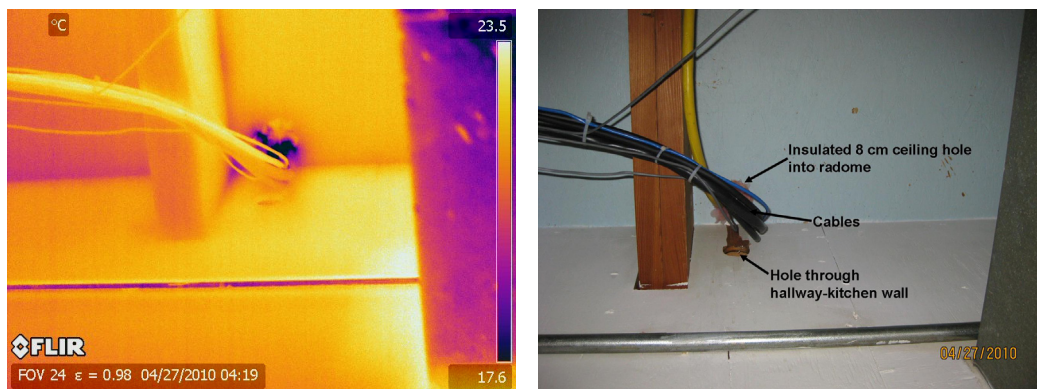
Figure S-5. Well insulated cable pass-through into radome.

Similarly, more heat loss was observed along the south side fascia, particularly toward the eastern end of the building, where instruments had previously been installed and in locations where repairs had been made to the metal flashing. Figure S-4 illustrates the heat loss observed in the IR imagery from the south side eastern end of the building. The cable pass-through to the radome (Fig. S-5) is an example where the cable pass-through is well insulated and little heat loss occurs.

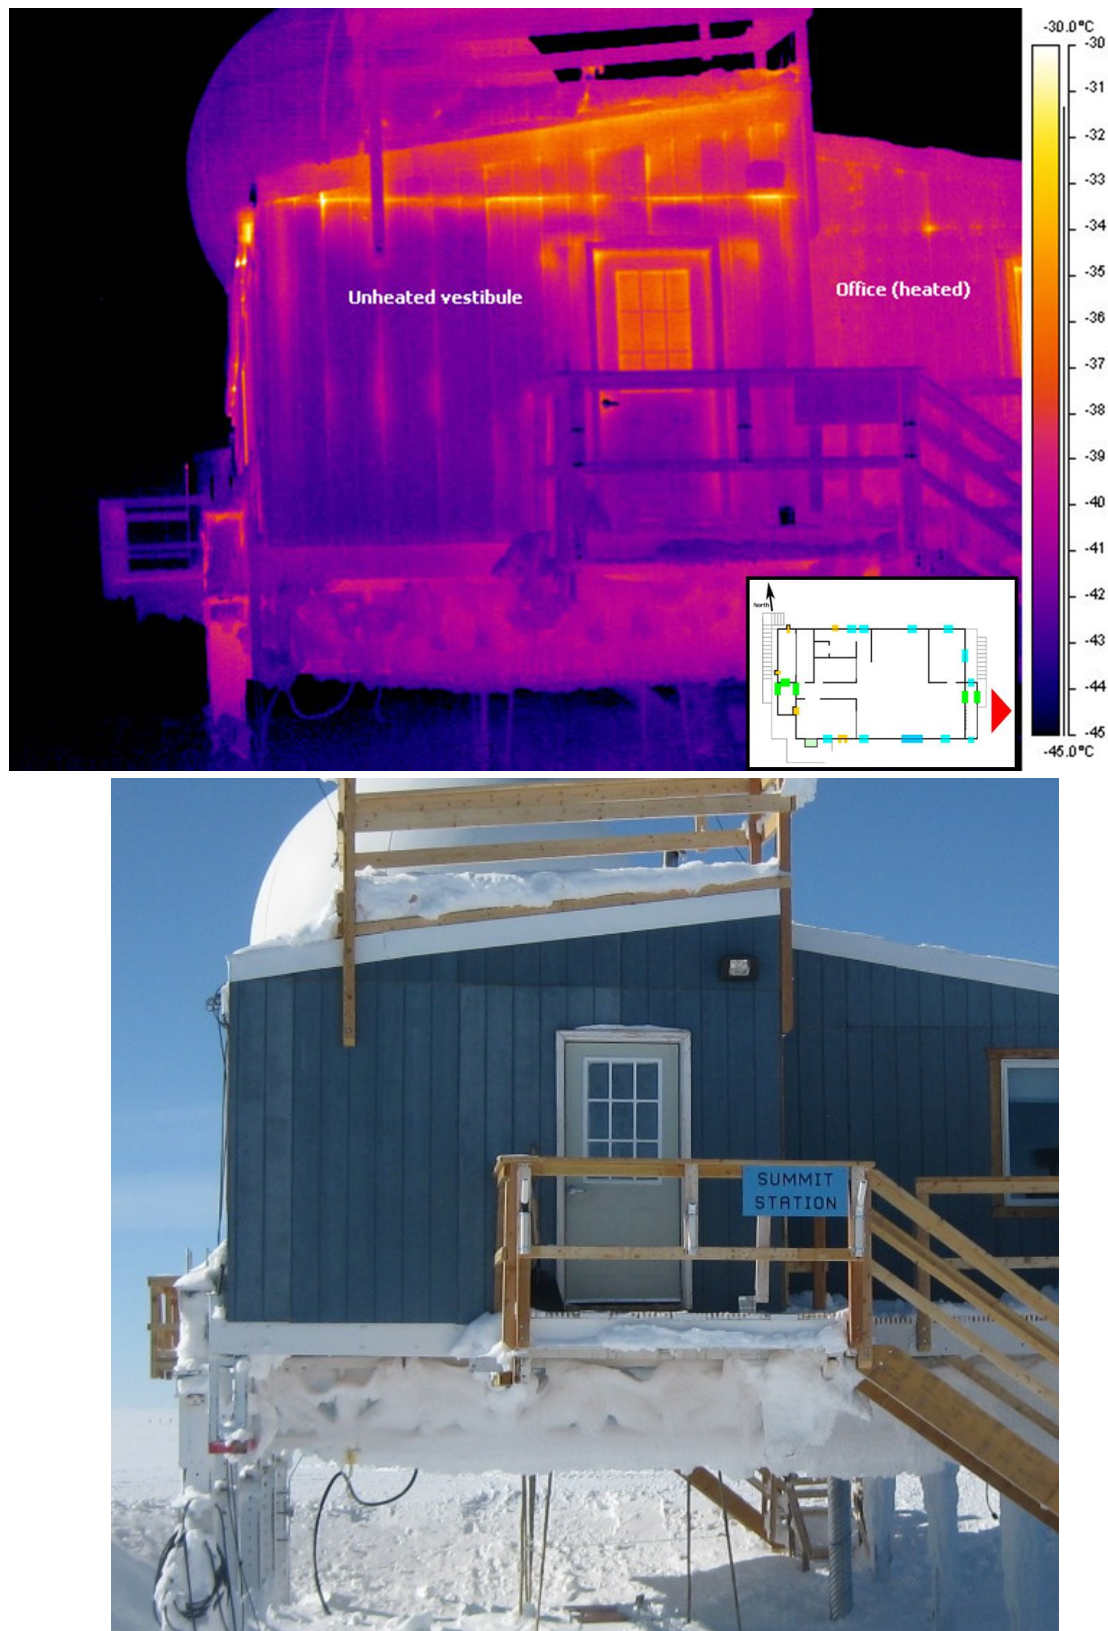
Figure 18. View 6 showing location (inset), thermal, and visual image of the eastern end of the Big House.

View 6, shown in Figure 18, is the southern portion of the eastern end of the Big House, and highlights the unheated entry vestibule. Again, the bright horizontal line at the interface of the T-111 siding indicates heat loss from the upper ceiling of the vestibule. The ceiling in the vestibule is open and slanted. The access hatch to the roof is located in the ceiling of the vestibule. During the visit, there was a substantial amount of frost built up on the access hatch on the inside of the vestibule.

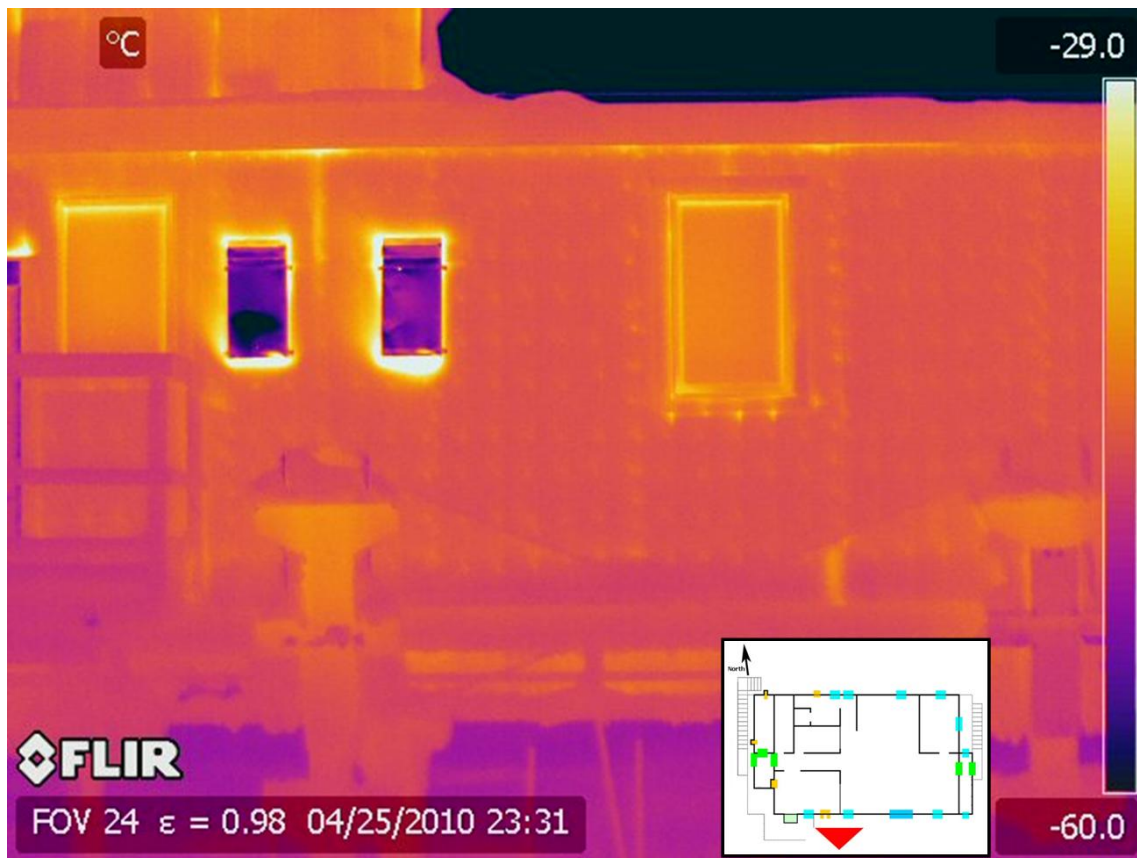
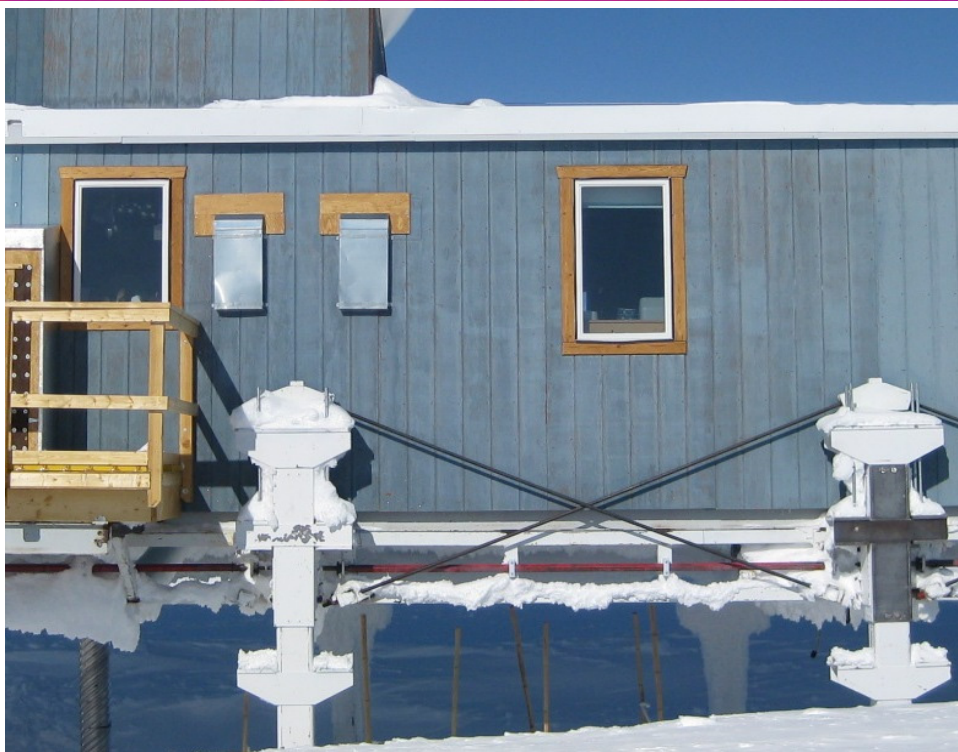
Figure 21. View 10 showing location (inset), thermal, and visual image of the south exterior wall in the vicinity of the kitchen.

The images in **View 10** (Fig. 21) include the kitchen stove vents and double-pane window (left) and the double-pane window in the main room dining area (right).

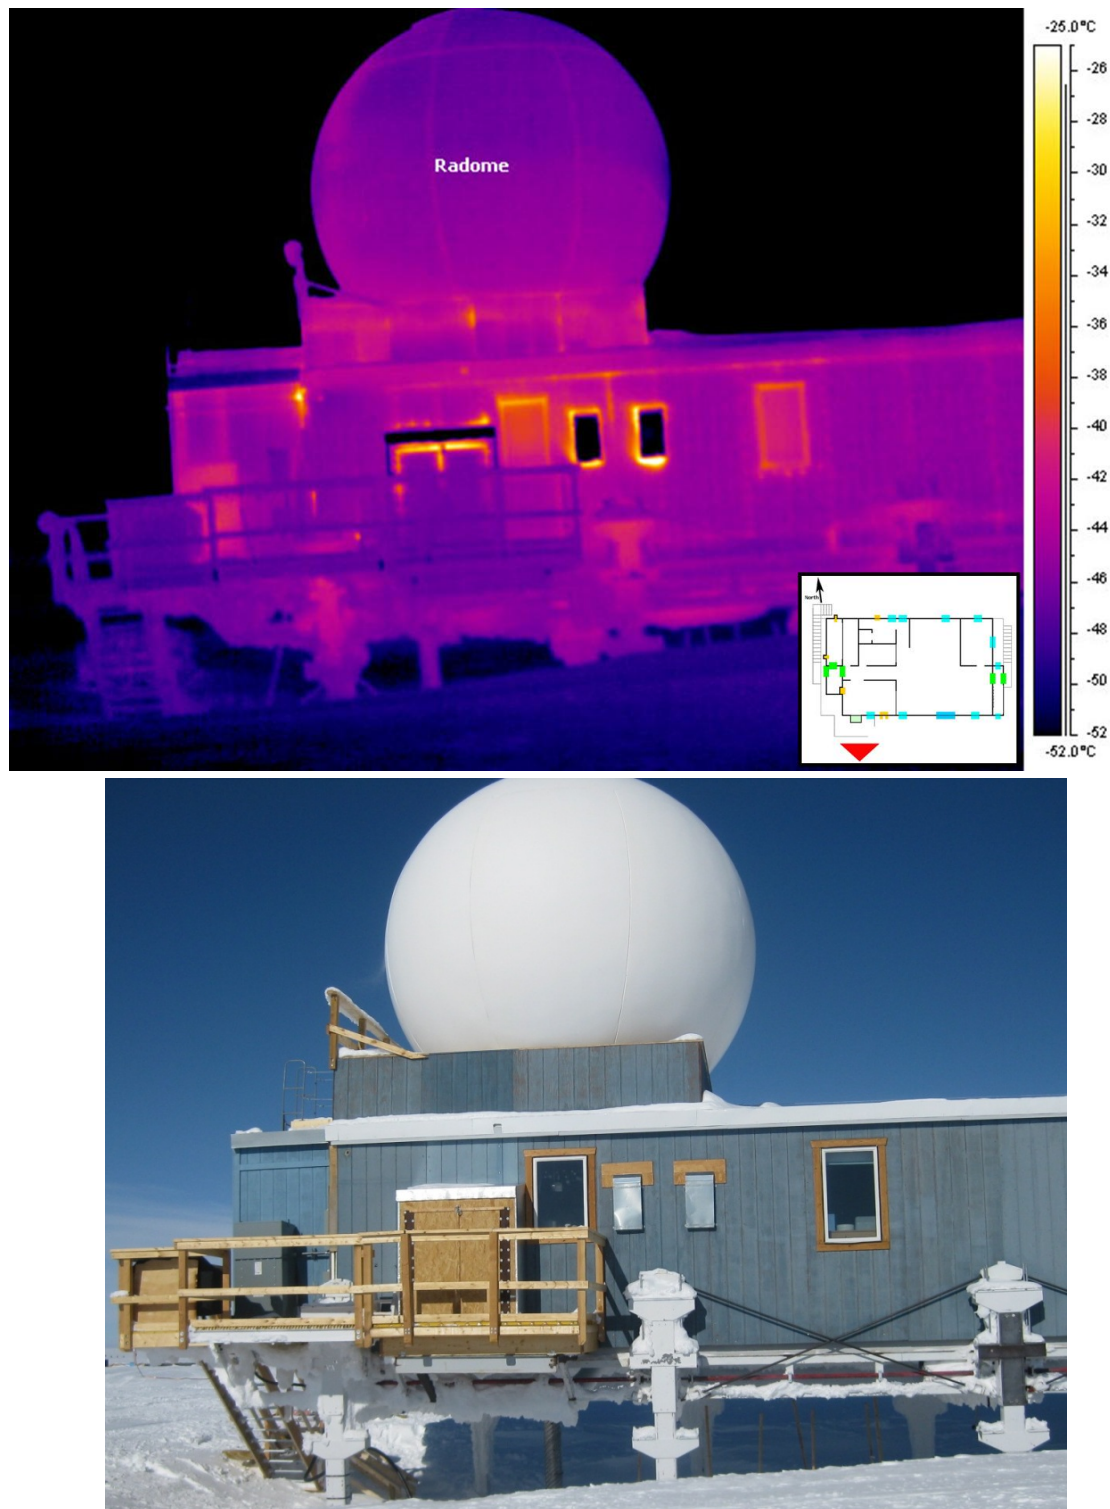
Figure 23. View 11 showing location (inset), thermal, and visual image of the of the south exterior wall west end in the vicinity of the kitchen.

View 11 (Fig. 23) shows the western end of the south side exterior wall, including the radome on the roof. The top portion of the radome base is warmer than the bottom, and there is another warm spot at the roof eave. There is a small heat trace system installed in the radome to keep the instruments warm. The box structure that supports the radome may retain some of this heat. The top of the radome is cold, suggesting that there is not an excessive amount of heat loss. While there is a small heat leak at the base of the radome, it is not a significant amount. On the ceiling inside the Big House are bolts that attach through the roof SIPs that secure the base of the radome. These images indicate some, but not a significant amount of, heat transfer along the bolts. Also shown in this IR image is the propane storage area (center of image, double-door behind deck railing) that shows some heat loss from the heater that maintains a suitable propane temperature. Improving the gasket around the storage doors would reduce this.

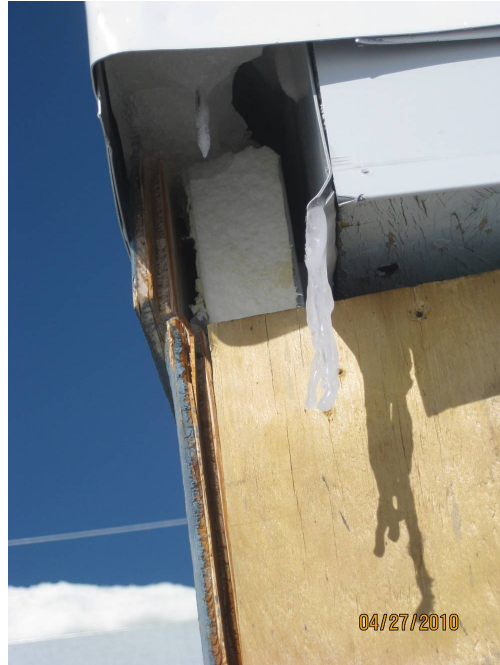
The southwestern corner of the building is shown in **View 12** (Fig. 24) where the west unheated vestibule connects to the main building. The southern portion of the vestibule contains shelving for dry goods and also houses the 600- × 600-mm fresh air intake into the kitchen. The very bright spot at the interface between the main building and the vestibule is a gap indicating excessive heat loss. Further to the right, at the corner of the main building, the bright spot there is from a gap at the eave created when the building was re-sheathed (Fig. 25).

Figure 25. Closeup of the southwestern corner of the original main building showing the gap between the materials of the original exterior and the recent re-sheathing.

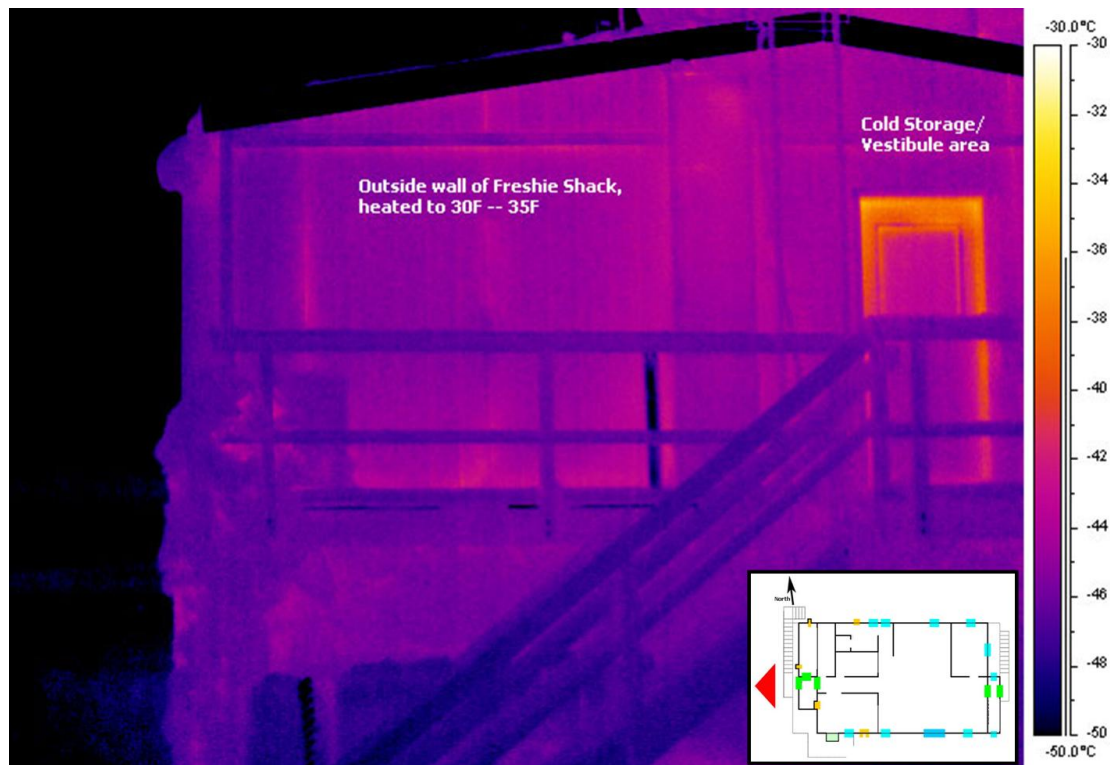
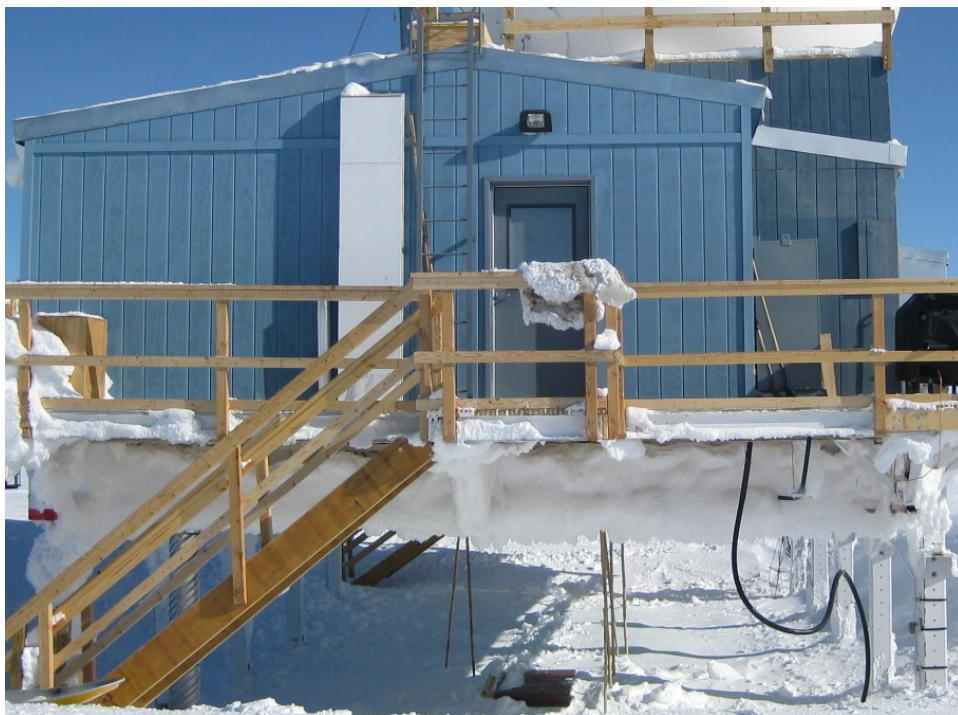
View 13, Figure 26 is a set of images showing the western end of the building. The vestibule is unheated and the freshie shack is located on the left side of the entrance. Heat loss is seen as the bright area along the top of the doorway. In the photograph, the white box (to the left of the doorway) is the vent for the summer intake fan into the freshie shack. It was covered with cardboard inside at the time of the IR survey. No significant heat loss is apparent.

Figure 26. View 13 showing location (inset), thermal, and visual image of the of the west end. The freshie shack is on the left side of the entry door.

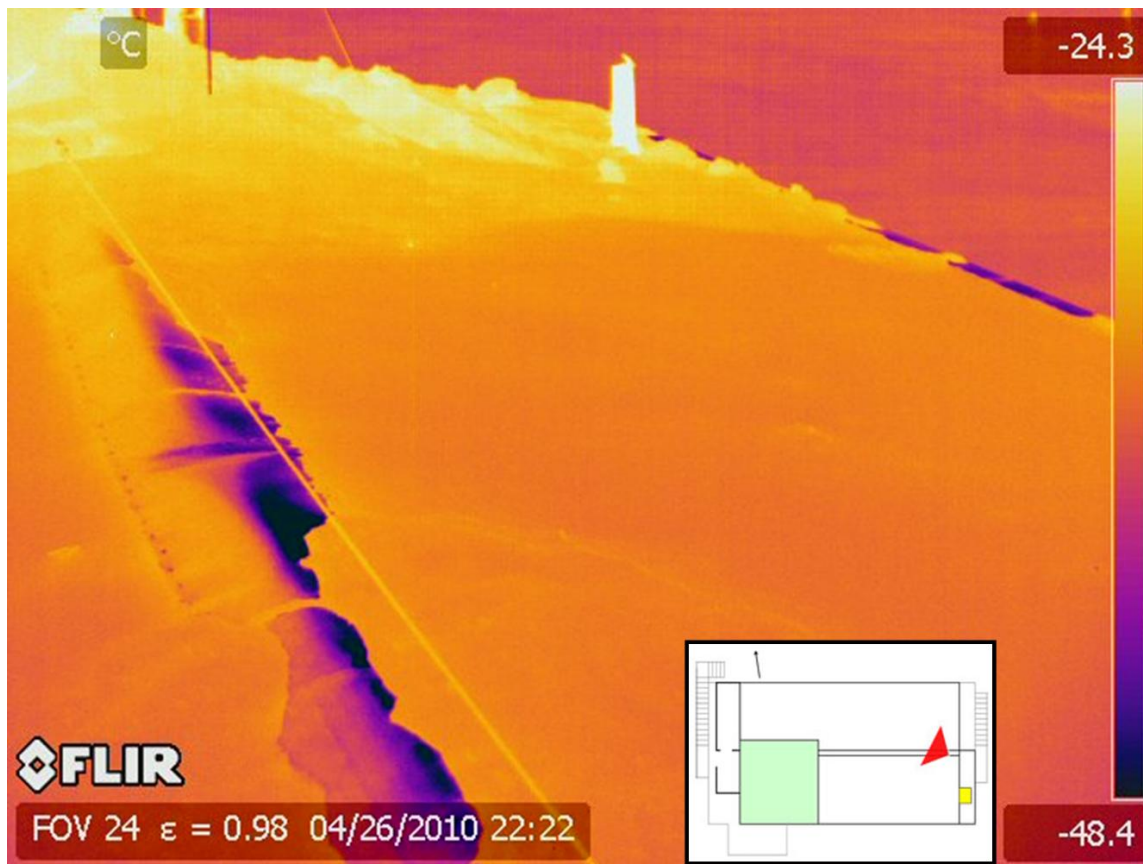
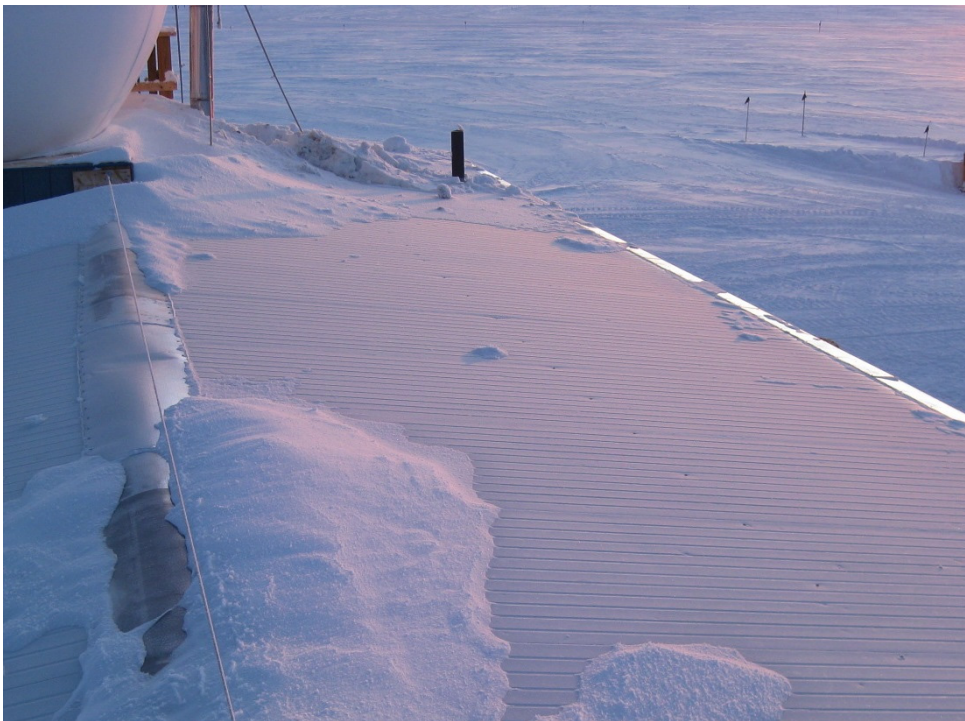
Both IR and visual images looking at the western end of the roof were taken by CPS personnel (for safety reasons) from the eastern end of the building. The images shown for **View 15** in Figures 27 and 28 are the north and south sides, respectively. The bright pipe in the northern view (Fig. 27) is the heated sewer roof vent. The view of the southern side (Fig. 28) includes the base of the radome. Aside from the previously mentioned heat loss from the support base of the radome, there is no significant heat loss from the roof. The dark areas are the reflection of the cold sky on the metal roof.

Figure 27. View 15 showing location (inset), thermal, and visual image of the northern side of the roof.

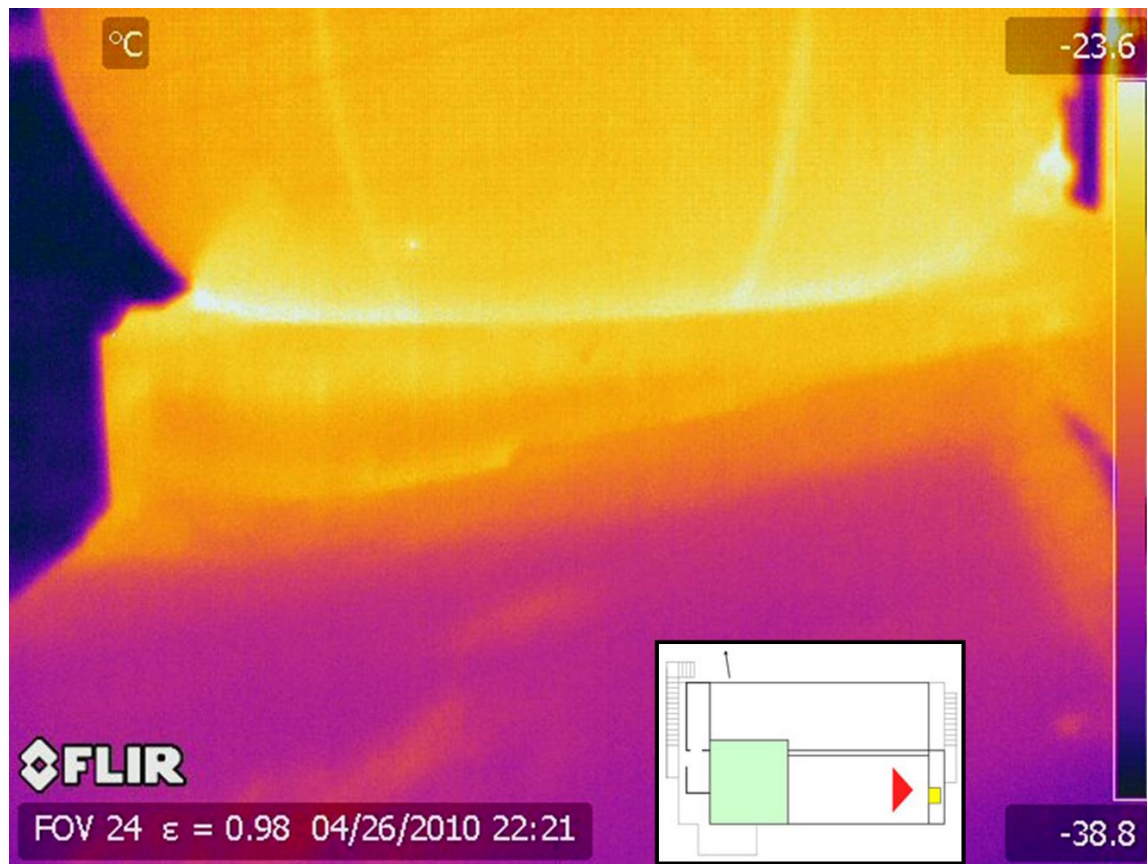
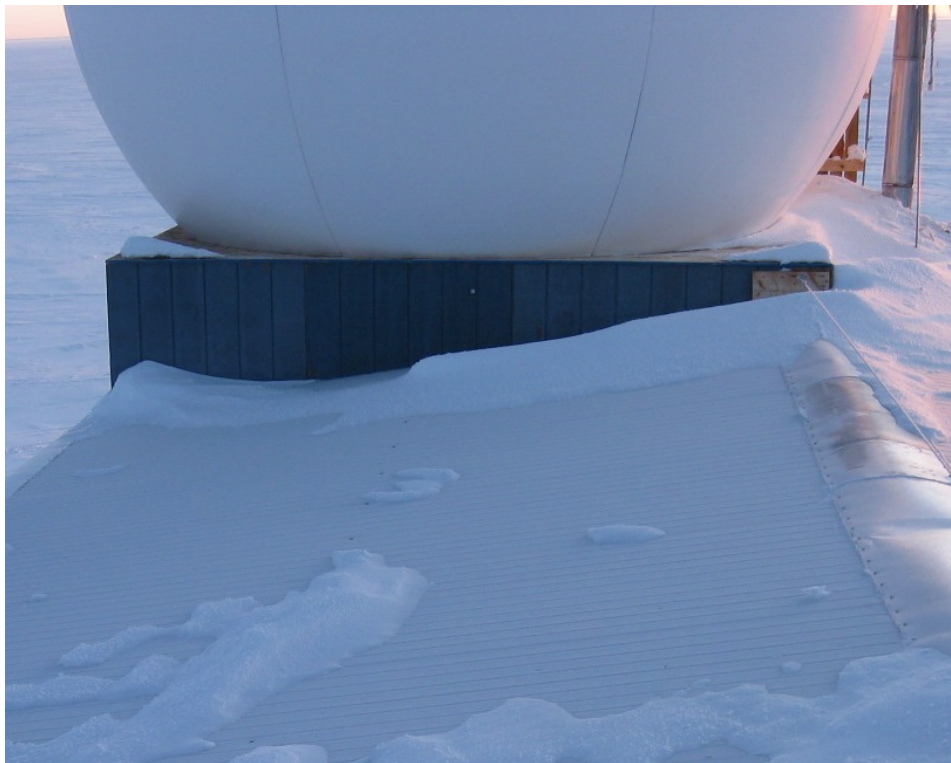
Figure 28. View of the southern side of the roof showing location (inset), thermal, and visual image taken from the same position (View 15).

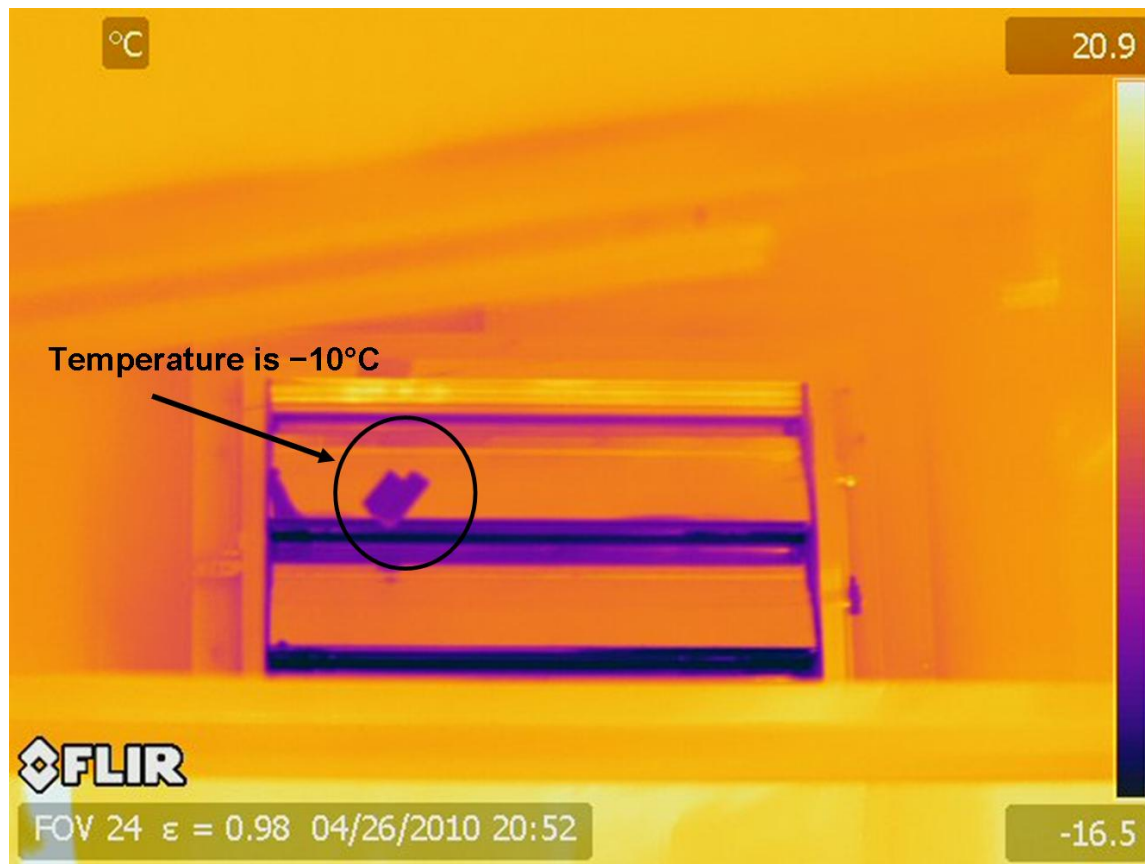
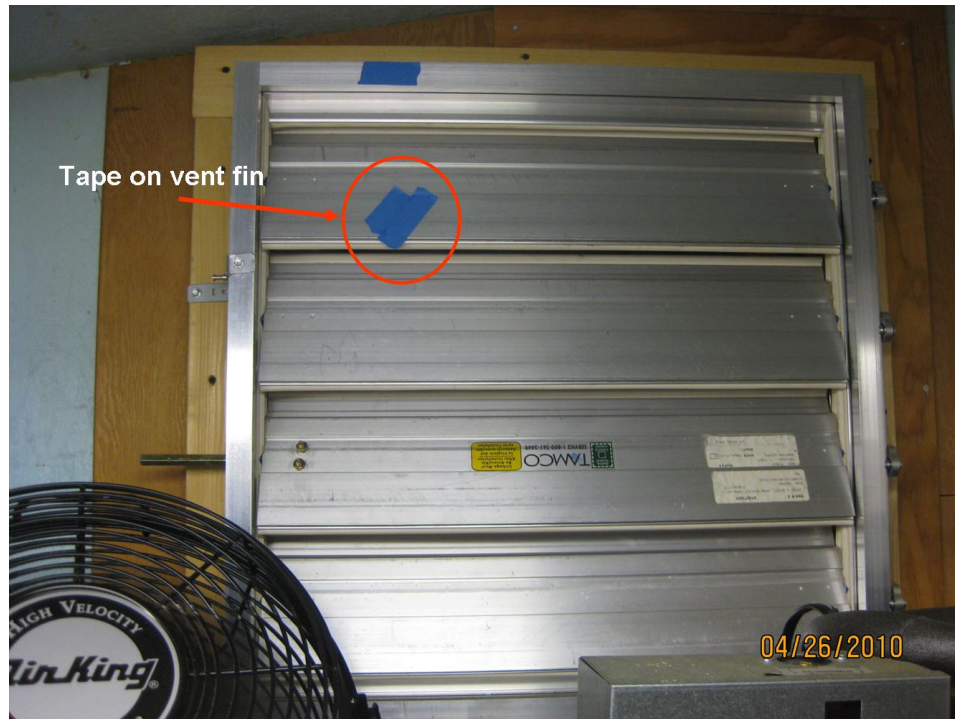
The large fresh air intake vent that brings outside air into the kitchen is a significant source of cold air infiltration (Fig. 33) and also supplies the building with make-up air for any combustion devices (such as the stove and furnace). The opening for the vent is on the underside of the building (Fig. 32). In contrast to the previous IR imagery, the dark colors here mean cold, as the vent fin is in contact with the cold air, and the warmer locations are reflected. The piece of blue tape on the top fin is reading -10°C . Also, in the west vestibule, there is frost buildup on the exterior of the vent under the shelves in the vestibule.

Figure 33. IR and visual imagery of the interior view of the large make up fresh air vent in the kitchen.

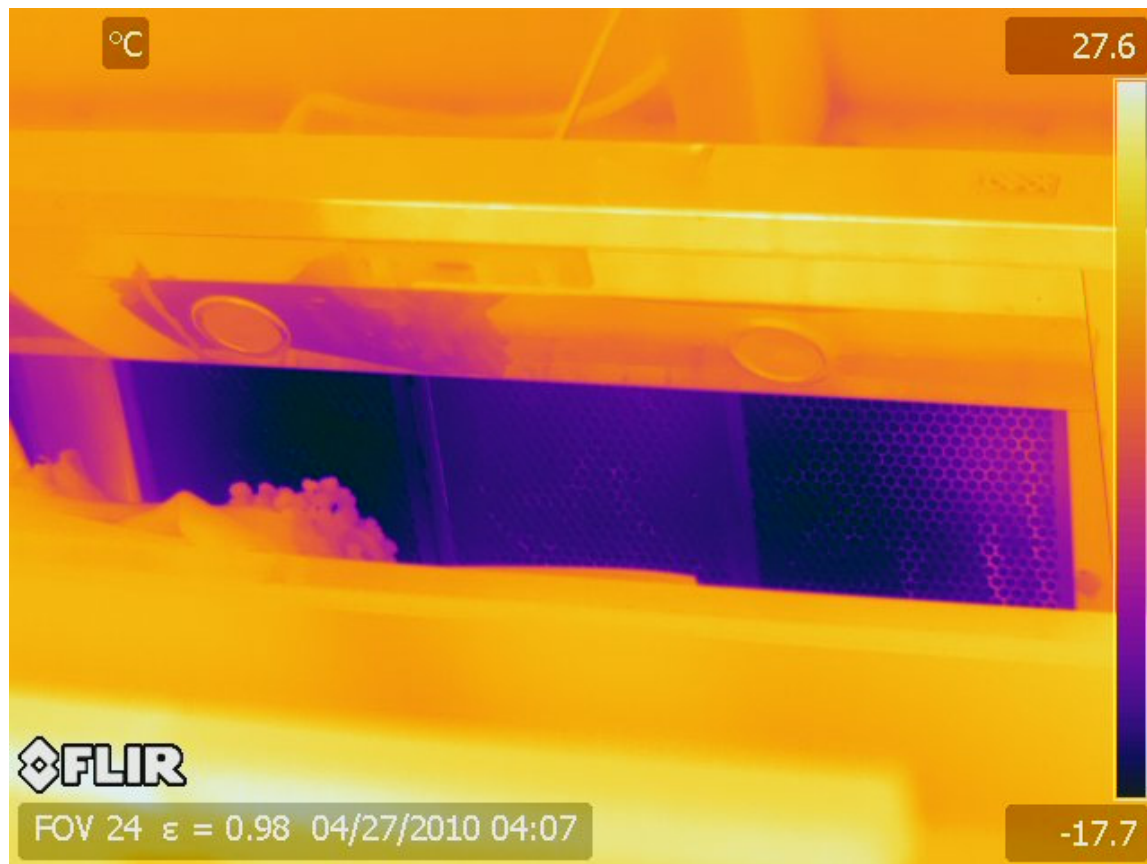
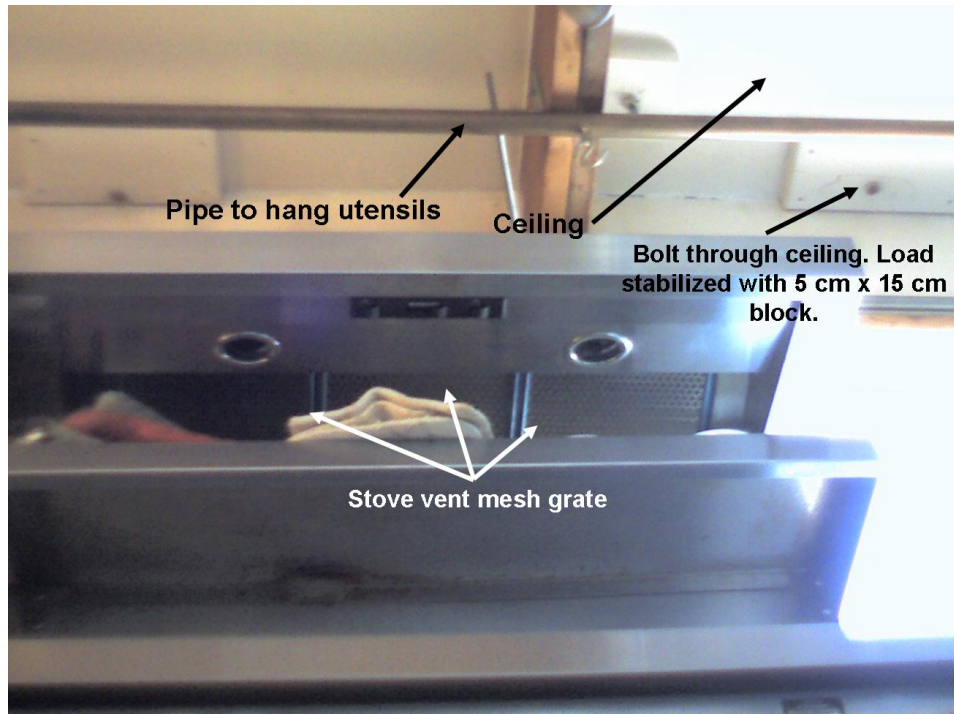
The vents located in the stove hoods are another location where cold exterior air infiltrates into the building, as shown in the IR image in Figure 34. Near this same place, on the wall behind the stove (Fig. 35), there is a cold location between two SIPs below the roof beam. This spot may be the same as the warm location seen on the exterior near the stove vents.

Figure 34. IR and visual imagery of the interior view of the stove vents in the kitchen.

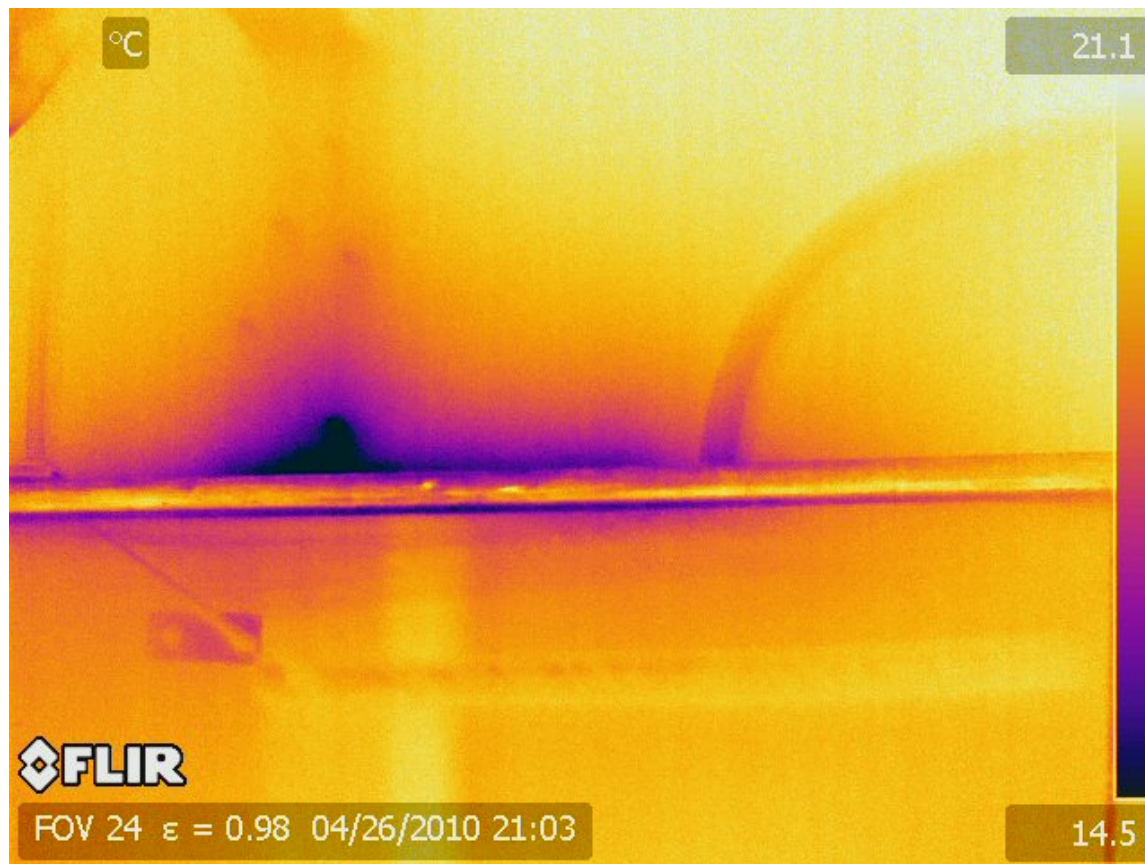
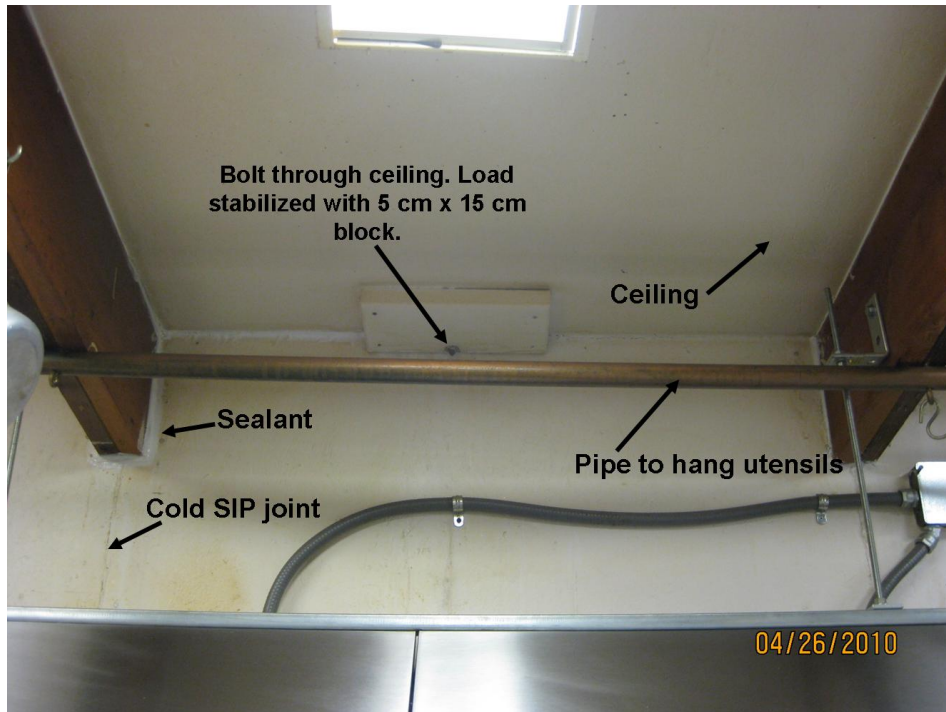
The bolts through the ceiling connecting to the base of the radome (Fig. 35) show locations of cold in the IR imagery. These are thermal bridges, and there are a number of these through the ceiling. They are condensation points for moisture in the air.

Also seen in Figure 35 is the sealant used around roof beams and along the roof-wall interface. This keeps the moisture from migrating through the wall.

Figure 35. IR and visual images of the roof-wall interface behind the stove in the kitchen.

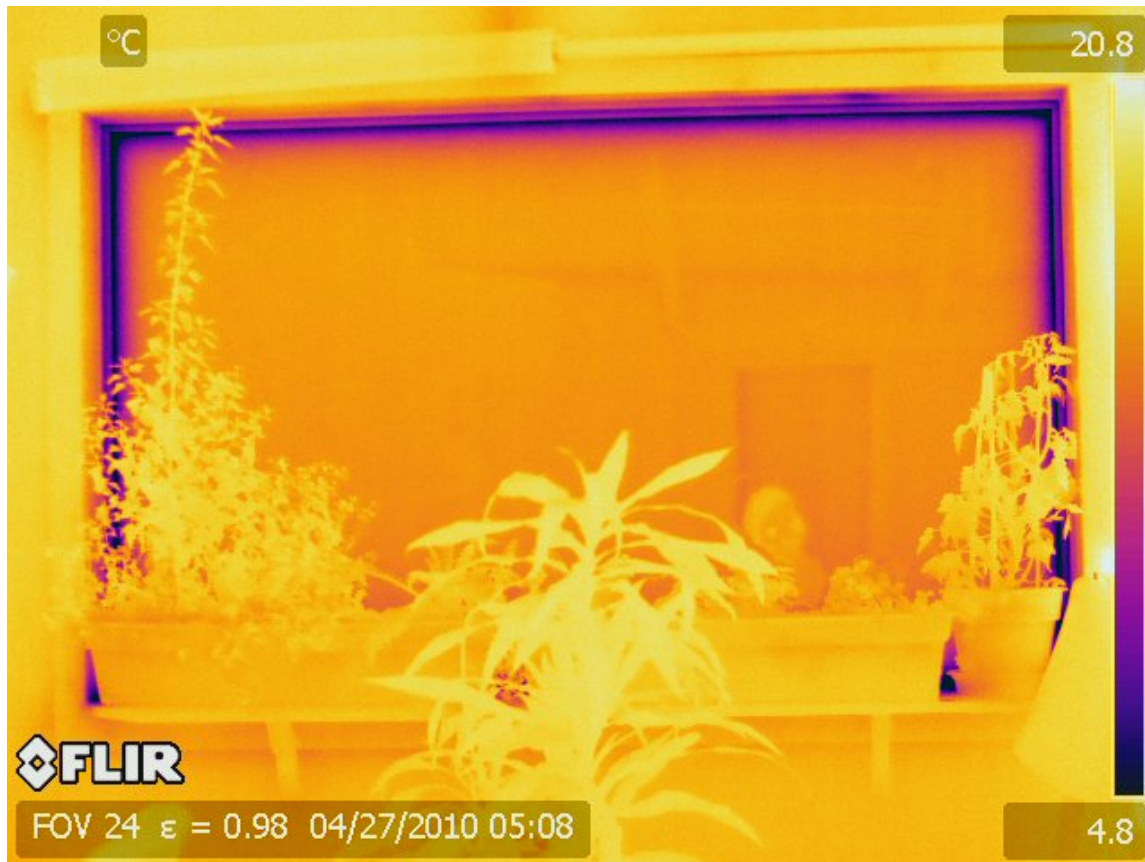
In Figure 37 the IR image of the quad-pane window shows a uniform temperature around the frame of the window. This is consistent with the exterior view and illustrates the difference in energy efficiency between the quad-pane window and the other windows.

Figure 37. IR and visual images of the quad-pane window in the main room.

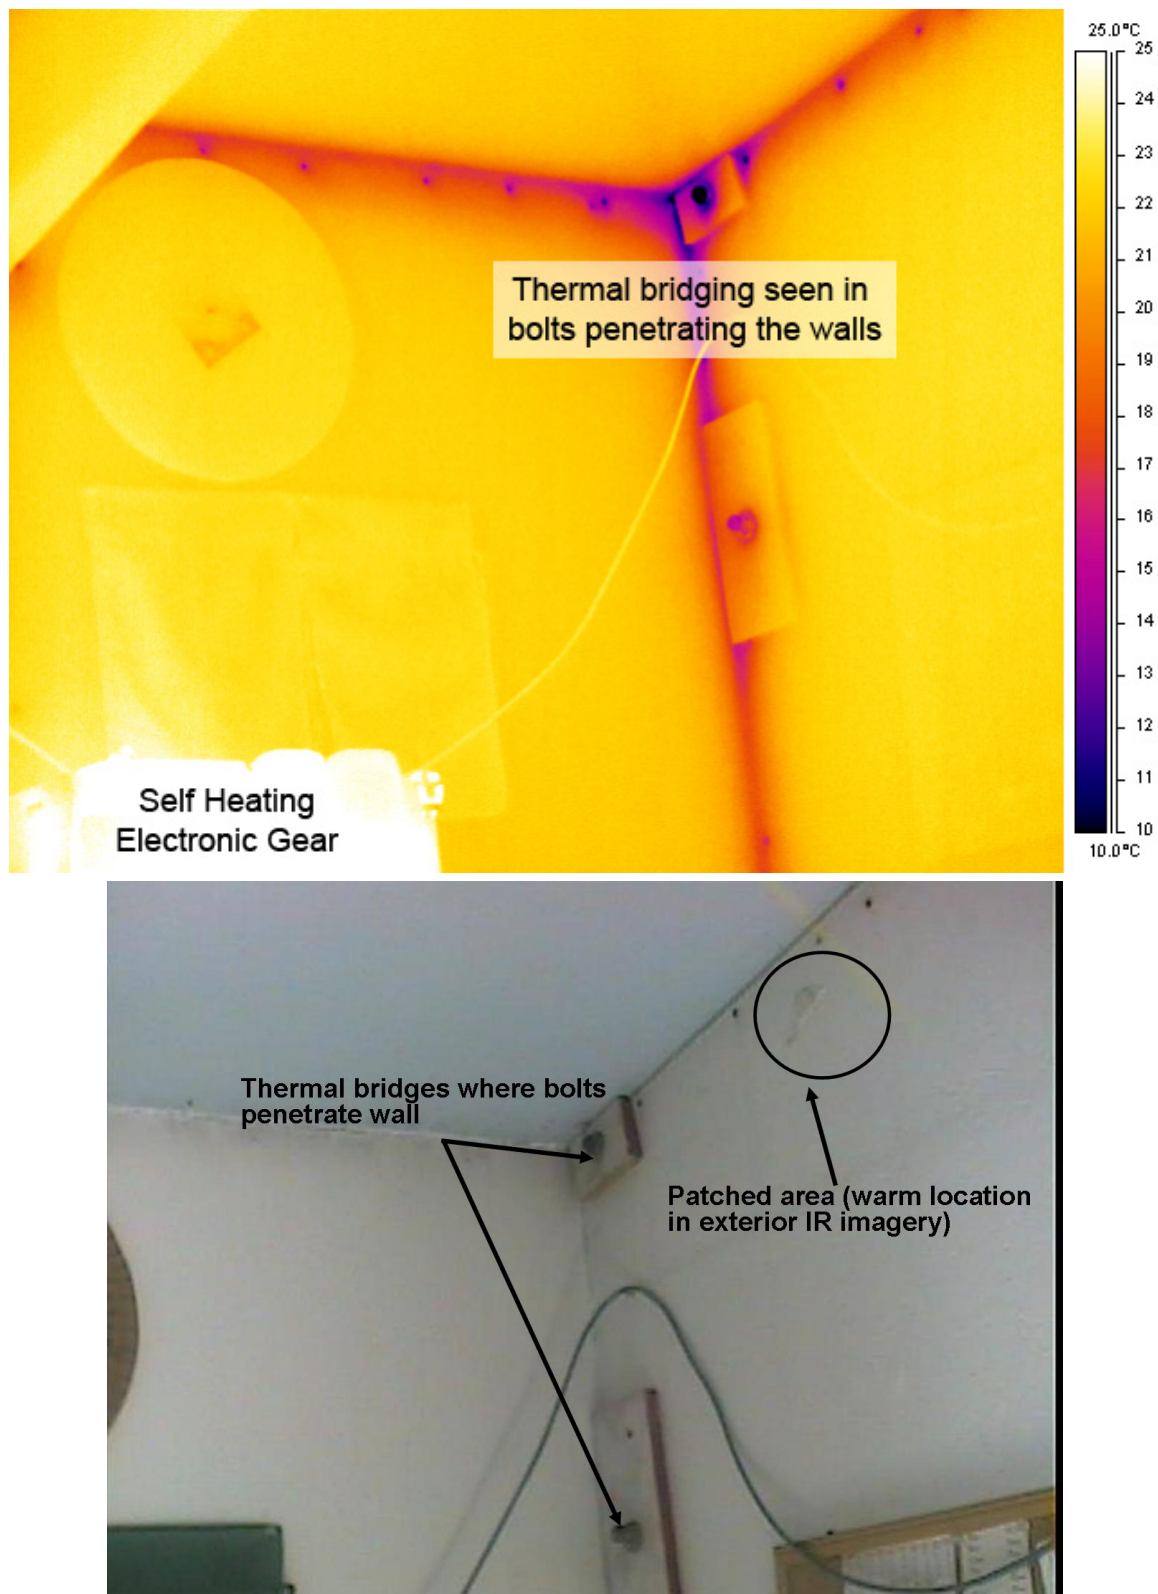
There are leaky locations that run the length of the northeastern corner in the office and also where there are bolts coming through the envelope attached to a piece of lumber on the outside (Fig. 39). Similar to the bolts through the ceiling in the kitchen, the bolts through the wall in the office are thermal bridges. Not visible on the interior is a warm spot on the wall (the location is noted on the visual image) that was visible in the exterior IR imagery.

Figure 39. IR and visual images of the northeastern corner in the office.

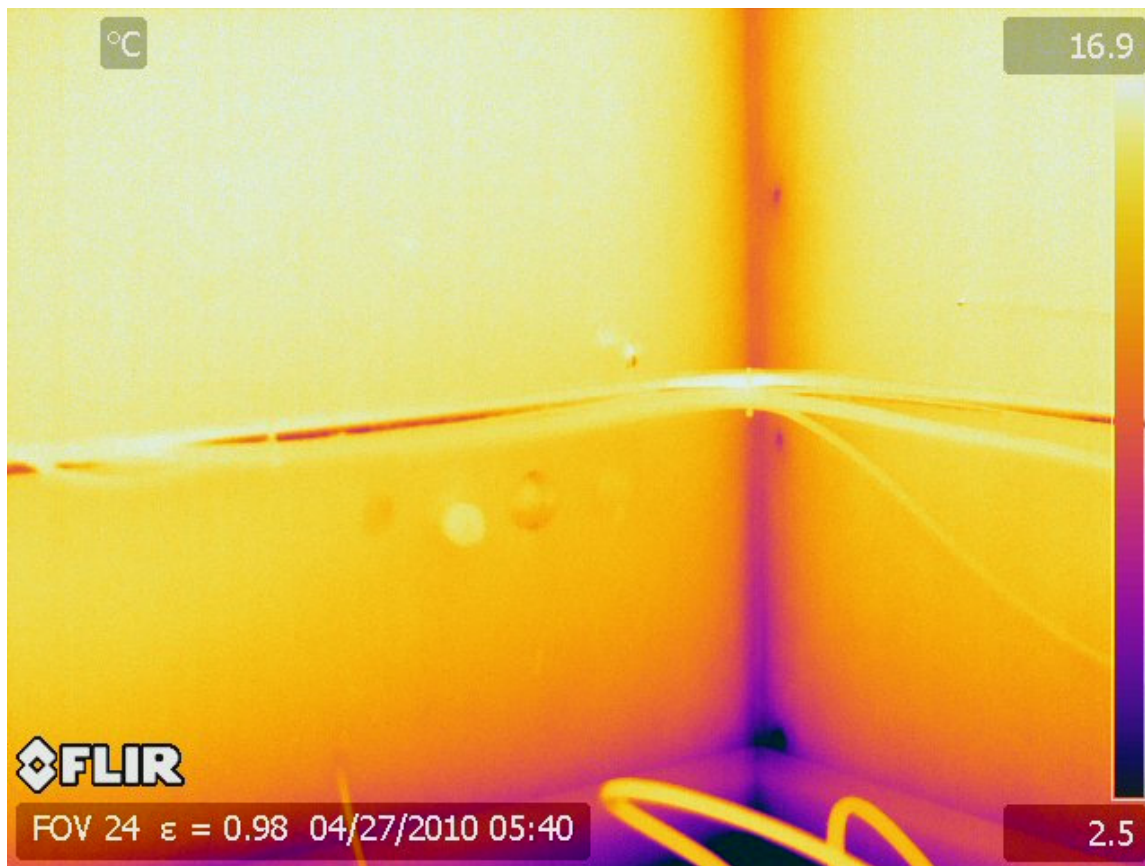
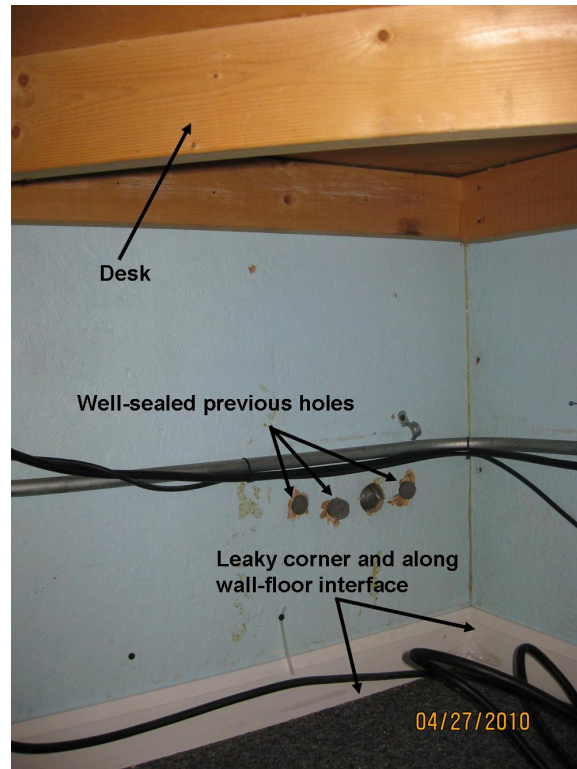
Figure 40. IR and visual images of the north-eastern corner below the desk in the office.

Below the desk (Fig. 40) are leaks at the corner and the wall–floor interface, with similar temperatures as the cold location under the counter in the main room. There are boxes and items stored under the desk that may be insulating this area so that the cold may not be noticeable to people working there. Also under the desk in this same wall were several holes that were well-sealed and did not show up in the IR imagery. It is recommended that previous penetrations to the building envelope that are no longer needed to support instrumentation be removed and completely re-insulated and sealed.
